CRS No. N14368

Name: Raymond and Marjorie Lane House

CULTURAL RESOURCE SURVEY
PROPERTY IDENTIFICATION FORM

6. PROJECT TITLE/REASON FOR SURVEY (if applicable):
U.S. 301 Project Development

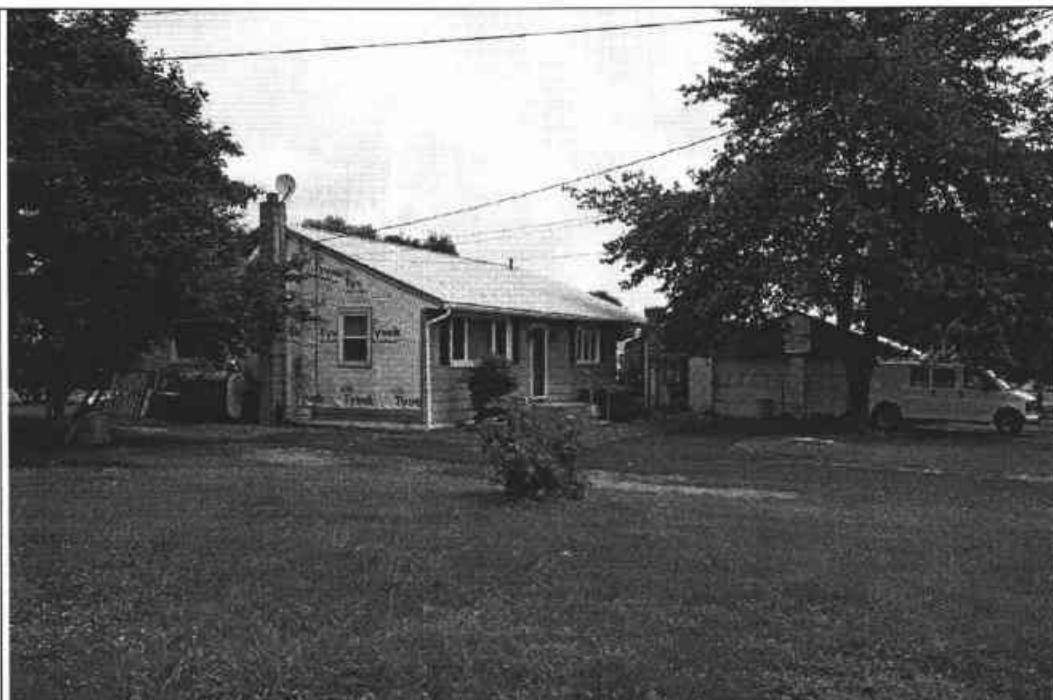
N14368. Photograph 1: Property overview, south and west elevations, view to northeast. This property represents a typical mid-twentieth-century Ranch style dwelling. Note the modern siding that is currently being installed.

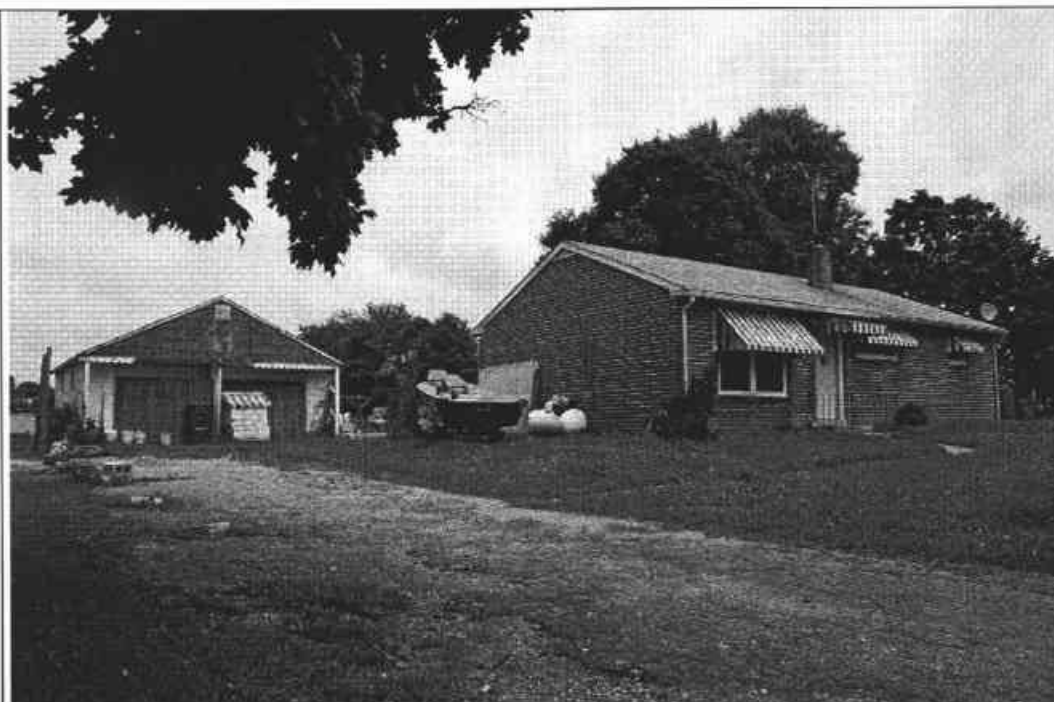
N14369. Photograph 1: Property overview, view to northeast. This property represents a typical mid-twentieth-century brick Ranch dwelling.

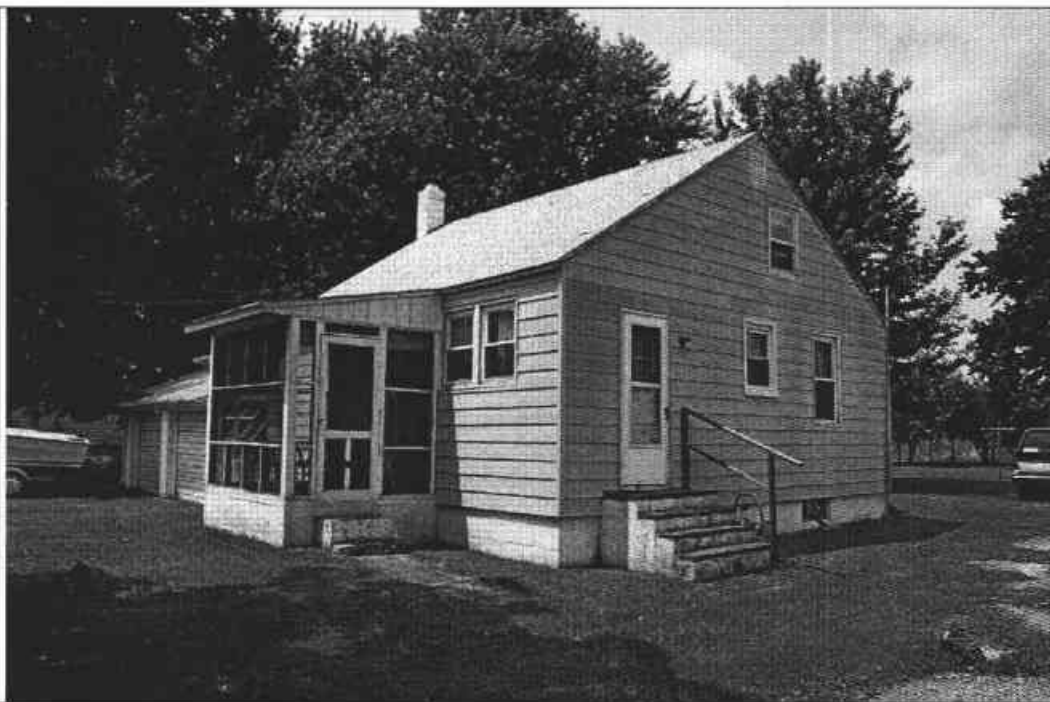
N14370. Photograph 1: Dwelling, south and east elevations, view to northeast. This property features an enclosed porch and a small rear addition. It is a typical example of a mid-twentieth-century Minimal Traditional dwelling.

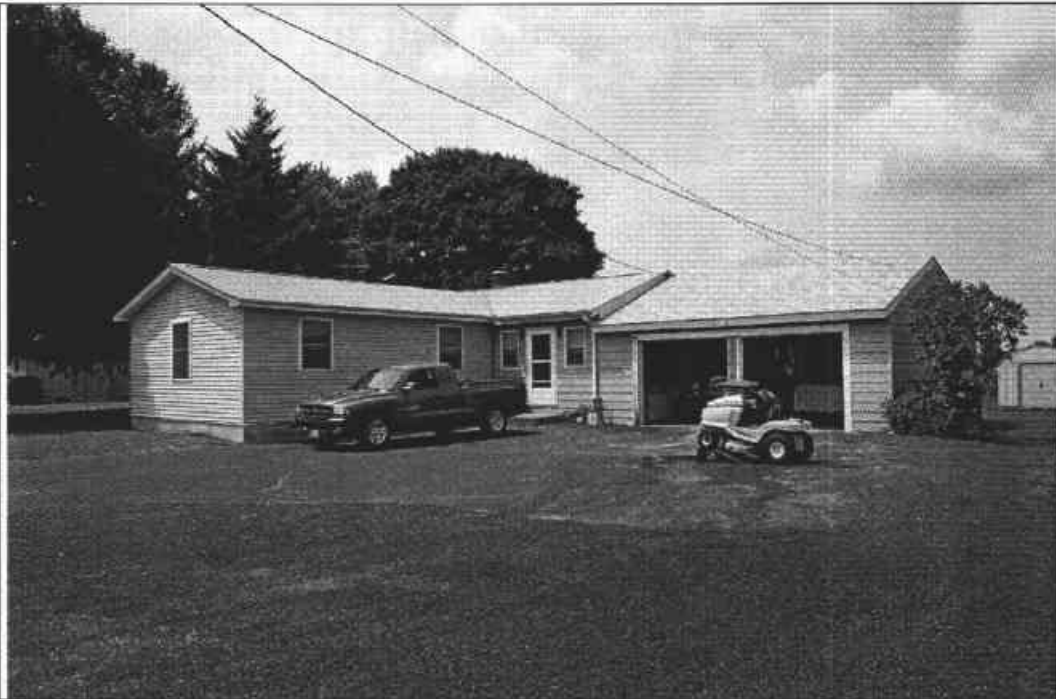
N14371. Photograph 1: Dwelling, south elevation, view facing northwest. Note the large gable addition as well as the attached garage.

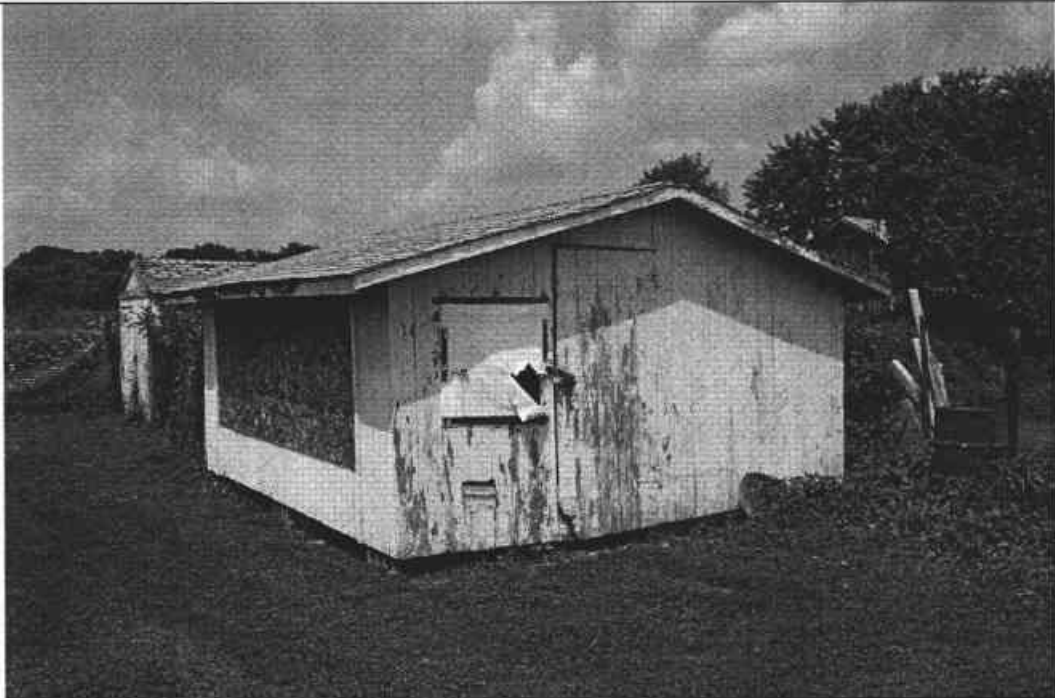
N14371. Photograph 2: Farm Building A, west and south elevations, view to northeast.

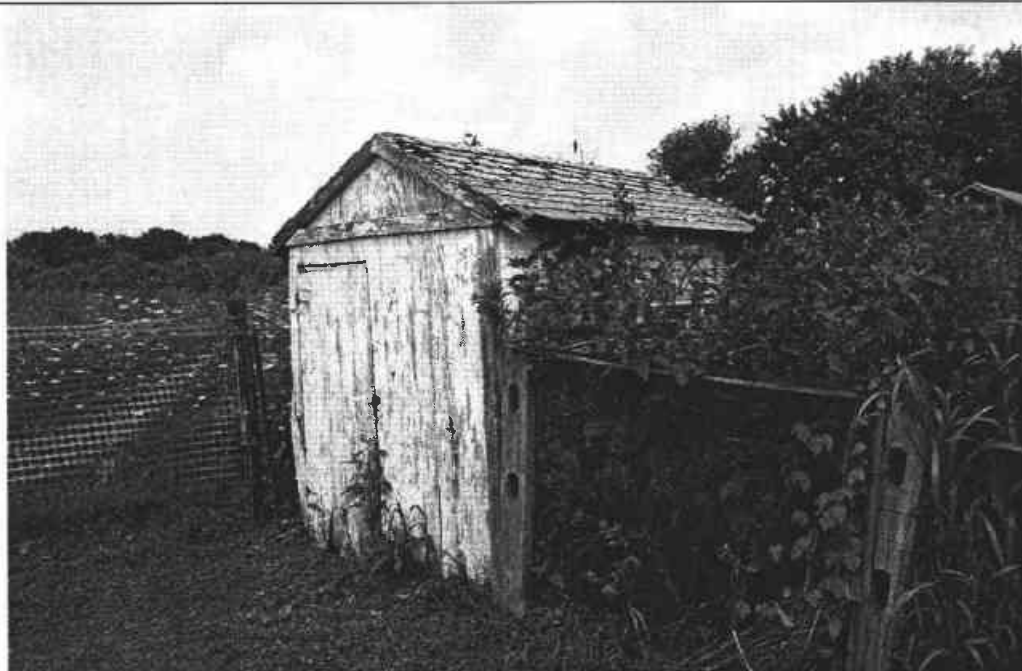
N14371. Photograph 3: Farm Building B, west and south elevation, view to northeast.

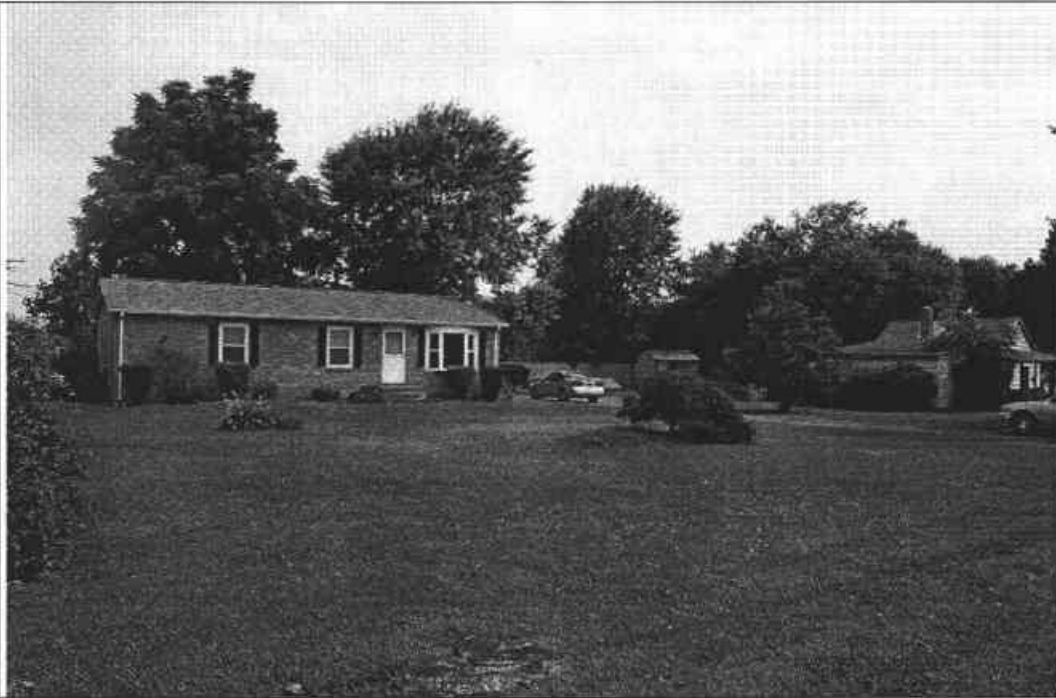
N14372. Photograph 1: Overview, view to the northeast. Note the modern dwelling, original gable front outbuilding, and small railroad building (center right).

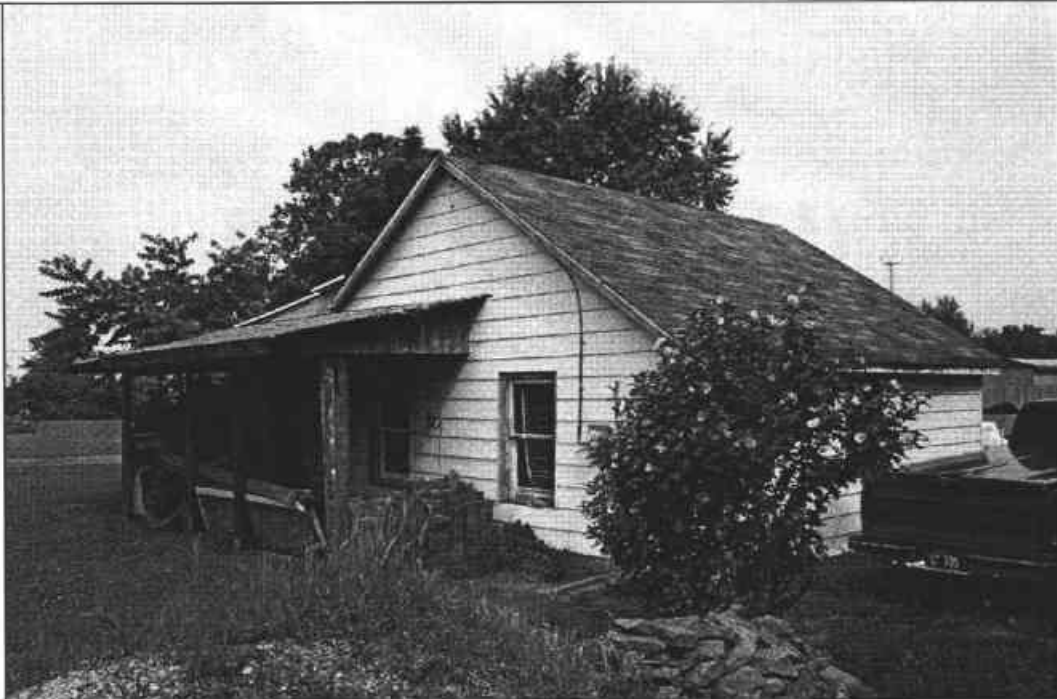
N14372. Photograph 2. Former garage structure, south elevation, view to the north. Note the wood shed porch addition.

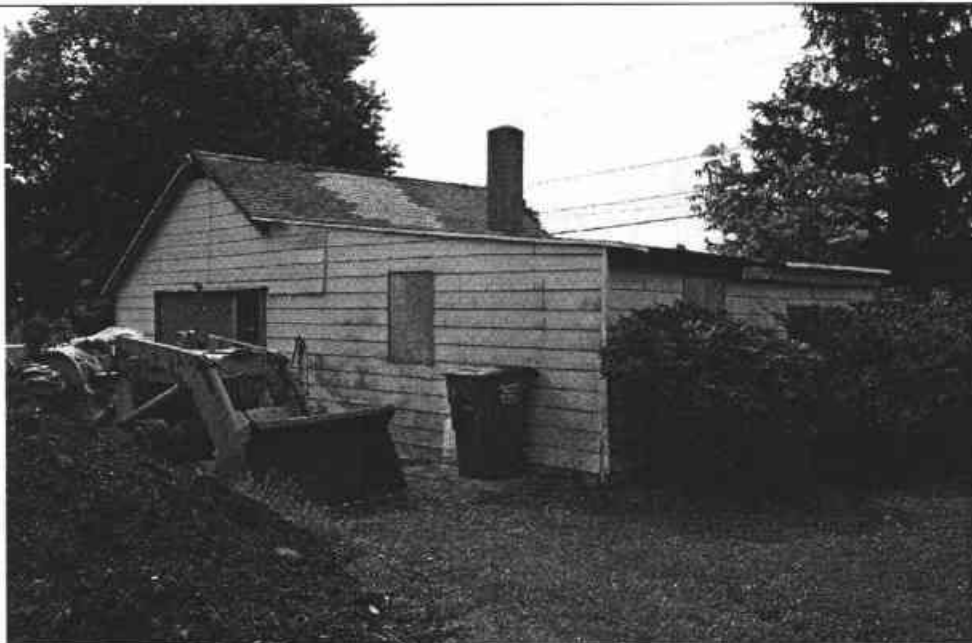
N14372. Photograph 3. Former garage structure, north elevation, view to the southeast. Note the former automobile opening that has been filled in and the boarded up windows on the addition.

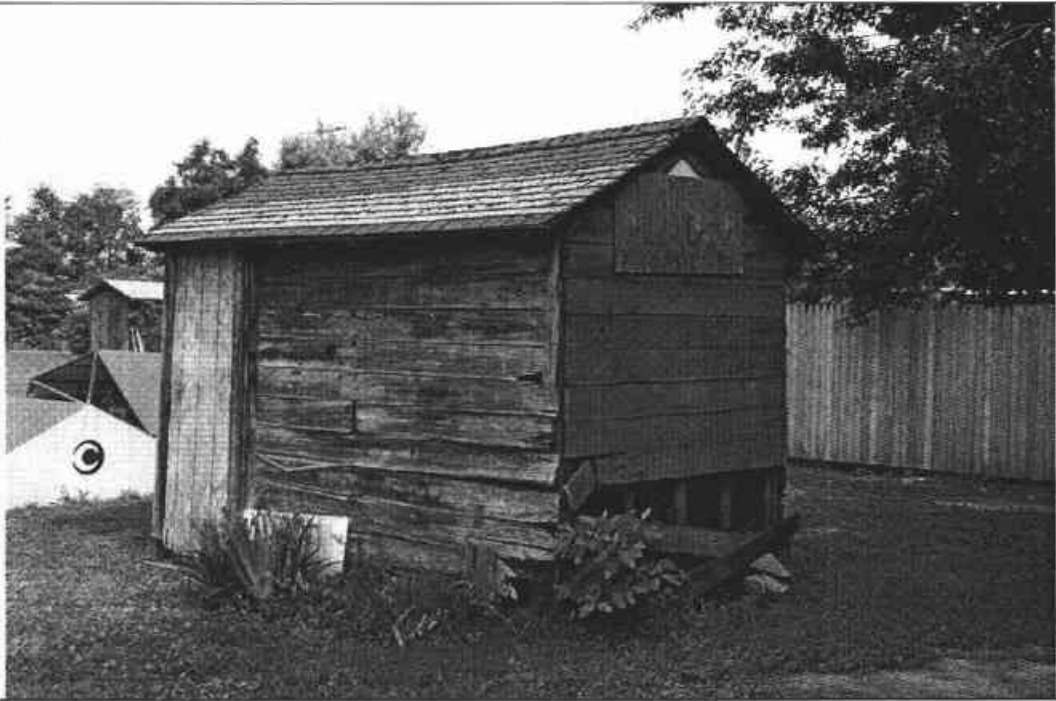
N14372. Photograph 4: Former railroad building, south elevation, view to north. Note the batten door and the missing wood planks on the east elevation. This structure has lost integrity of location and setting due to its relocation away from the proximity of the railroad.

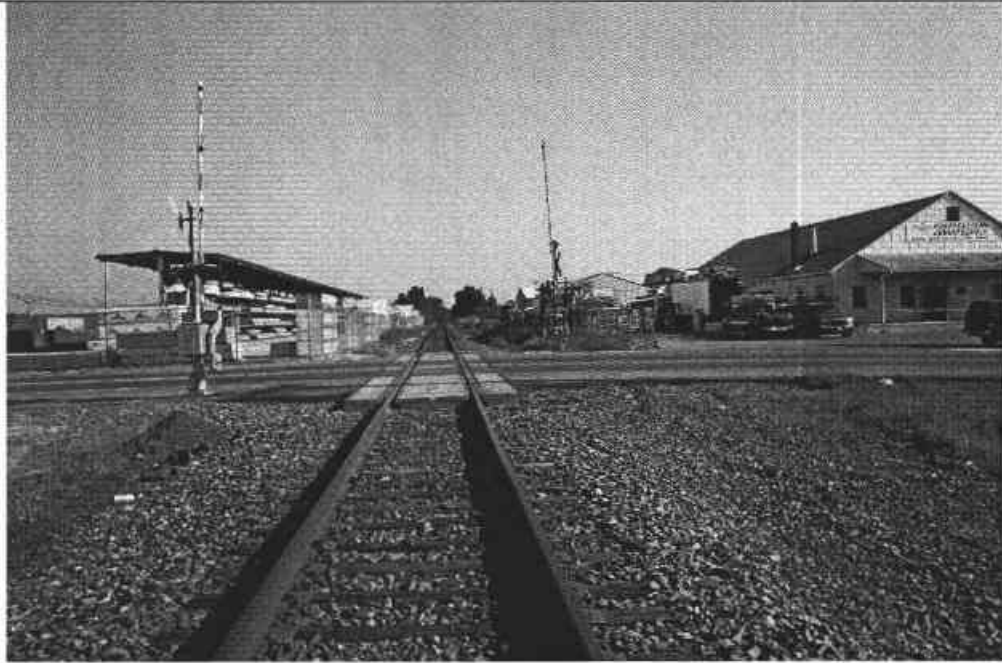
N14373. Photograph 1. Delaware Railroad. View of railroad at Middletown, looking north toward Main Street. Two commercial facilities along the railroad tracks that were surveyed for the U.S. 301 project are in this photograph, the current-day Shone Lumberyard on the left (CRS No. 14311) and the current-day Northeastern Supply (CRS No. N14362) on the right.

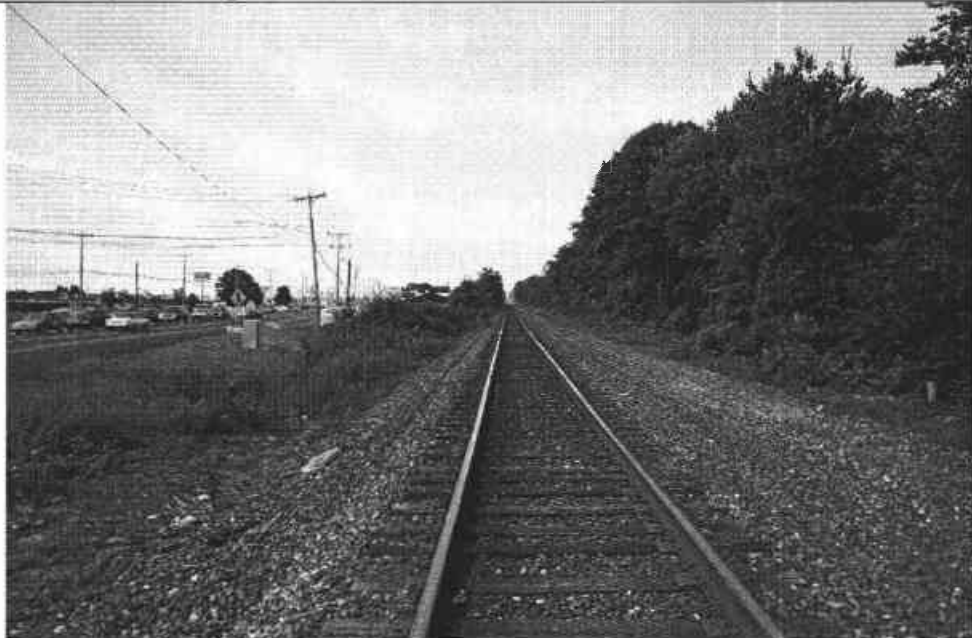
N14373. Photograph 2. Delaware Railroad. View of railroad to north of Middletown, looking north, showing U.S. 301 on left.

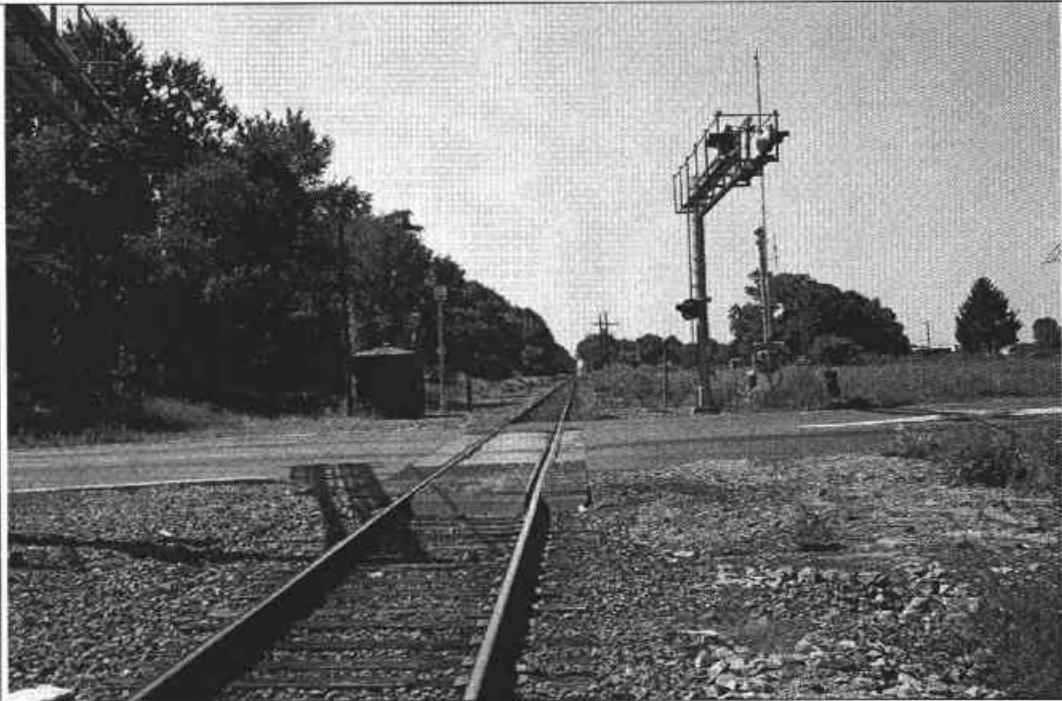
N14373. Photograph 3. Delaware Railroad. View of railroad at Mt. Pleasant, showing tracks and overhead signals, view looking north.

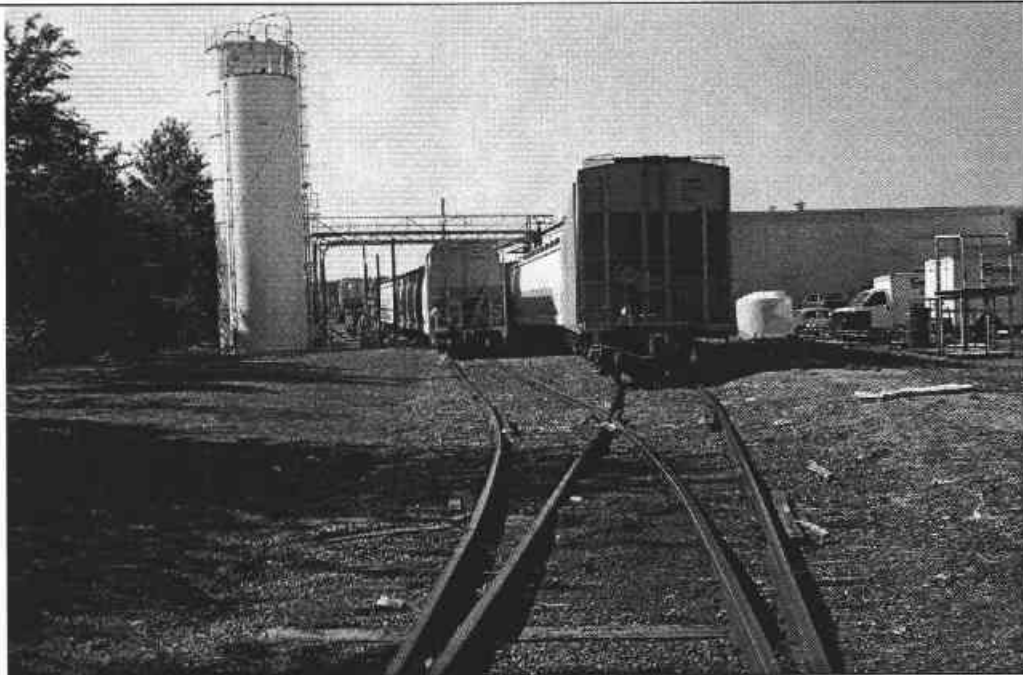
N14373. Photograph 4. Delaware Railroad. View looking south of railroad siding at a commercial facility in Middletown, near Industrial Drive. Photograph taken just outside the U.S. 301 APE.

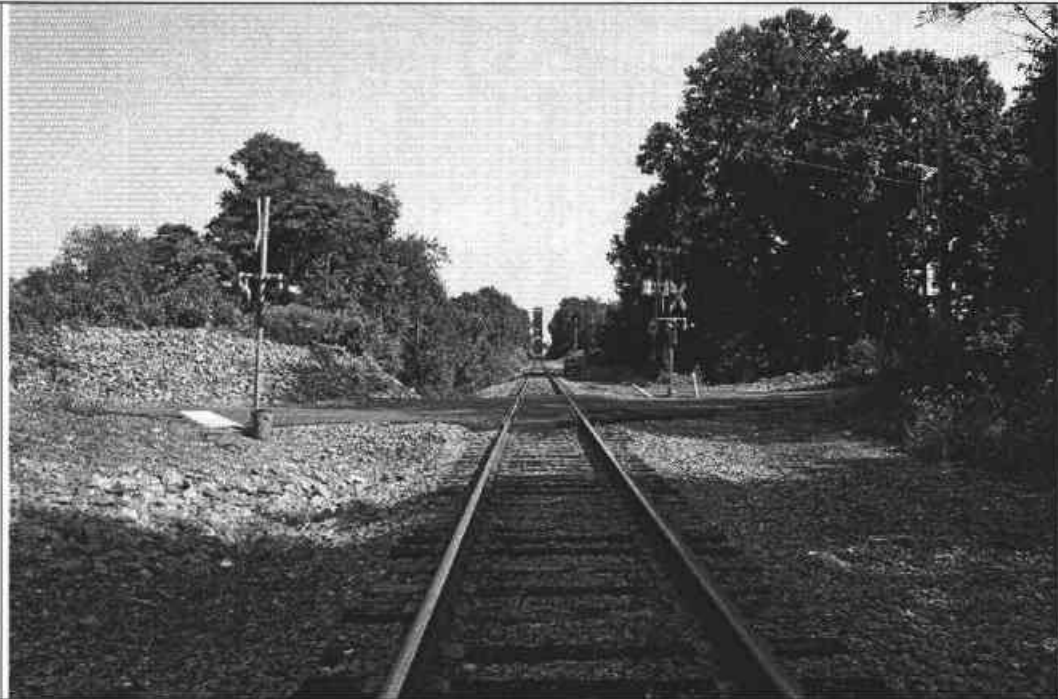
N14373. Photograph 5. Delaware Railroad. View of railroad at Lorewood Grove Road looking north, near northern end of project area. The high-swing bridge at the C & D Canal can be seen in the background.

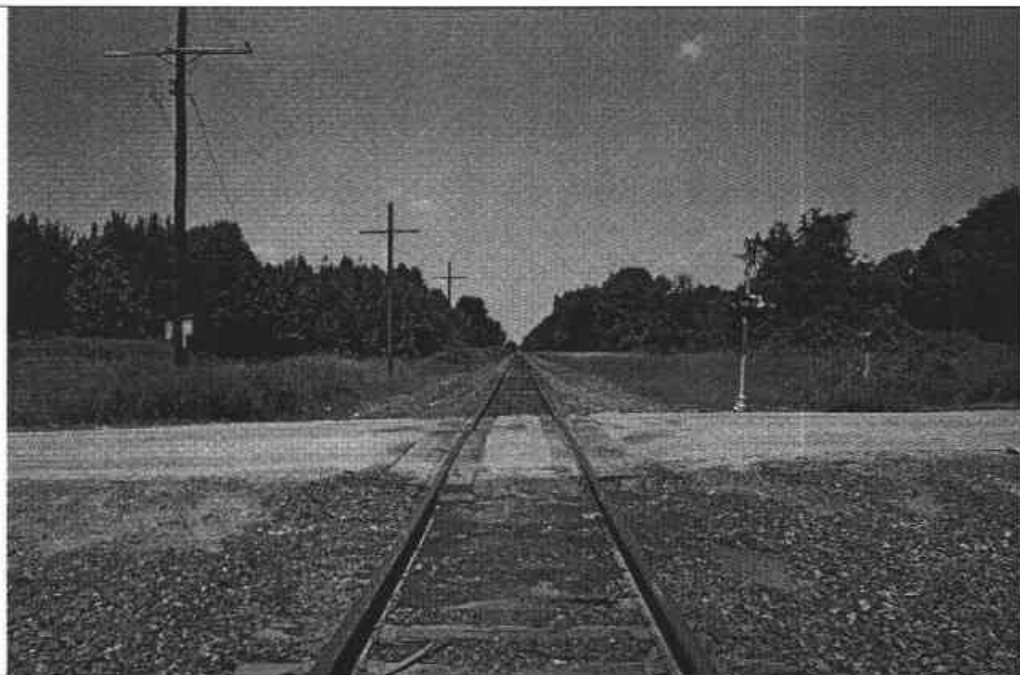
N14373. Photograph 6. Delaware Railroad. View of railroad at-grade crossing at Marl Pit Road near Armstrong Corner, looking north.

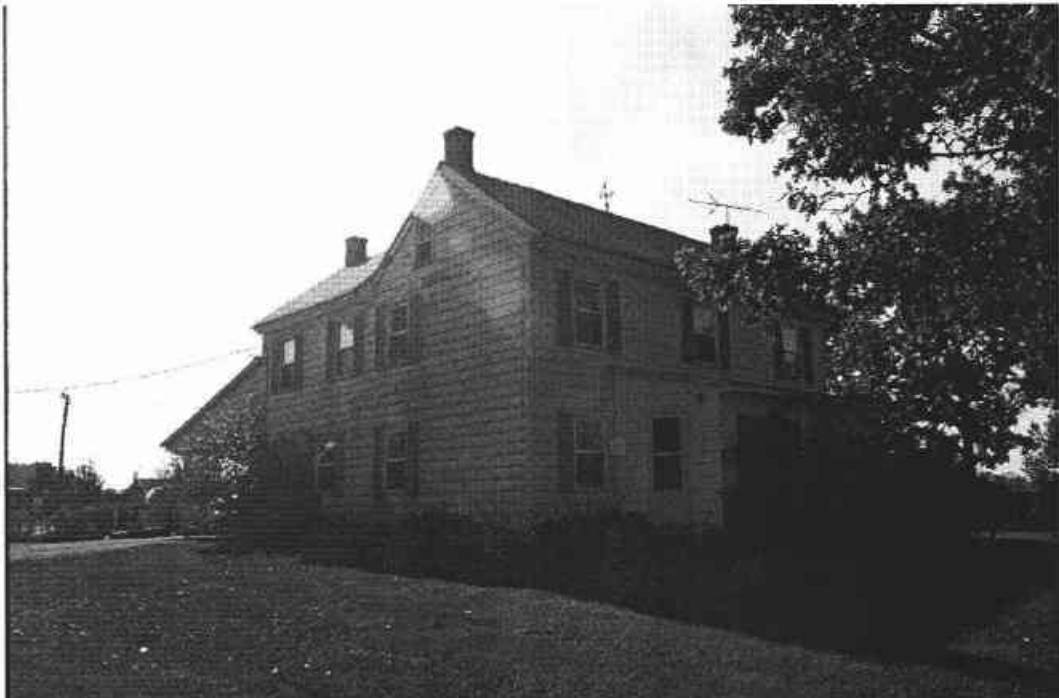
N14375. Photograph 1: Dwelling, north and west elevation, view to southeast. Note milk house and modern shed to rear of photograph.

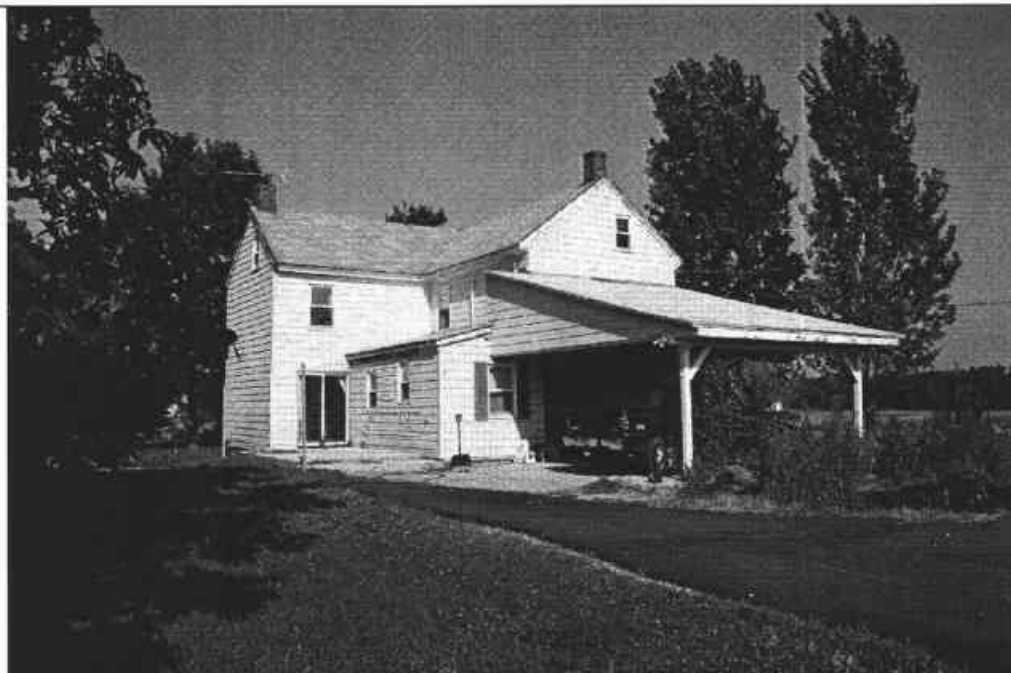
N14375. Photograph 2: Dwelling, south and east elevations, view to northwest.

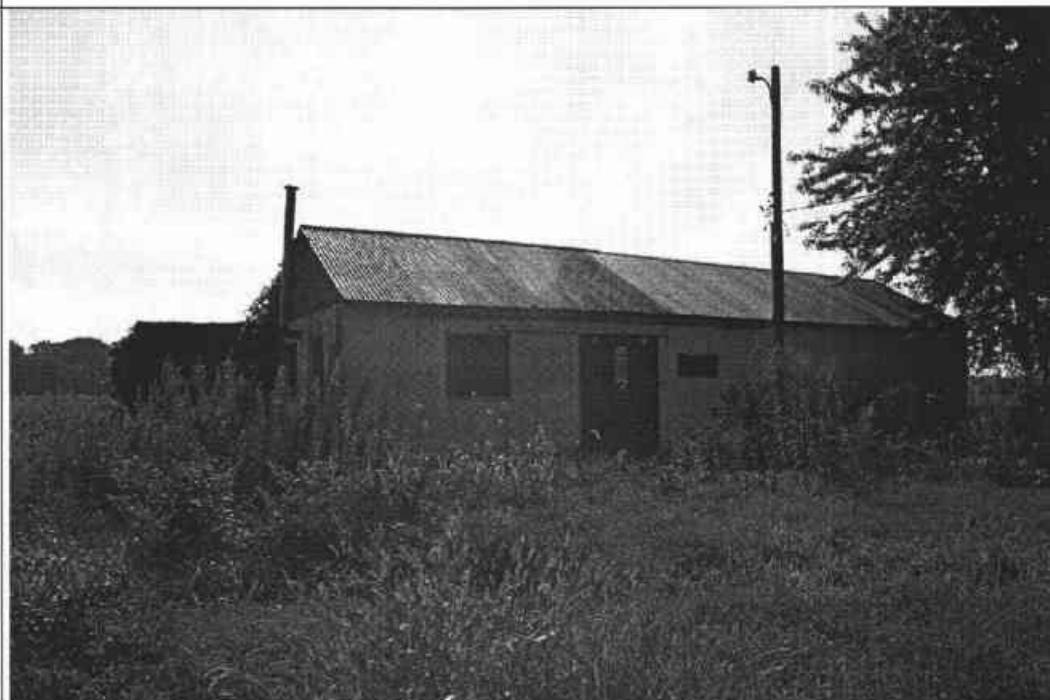
N14375. Photograph 3: Milk house, north and west elevation, view to southeast. Former barn is now gone.
